Demolition or Restoration: A Case Study

2. A CASE STUDY OF AL-AMIN MOSQUE

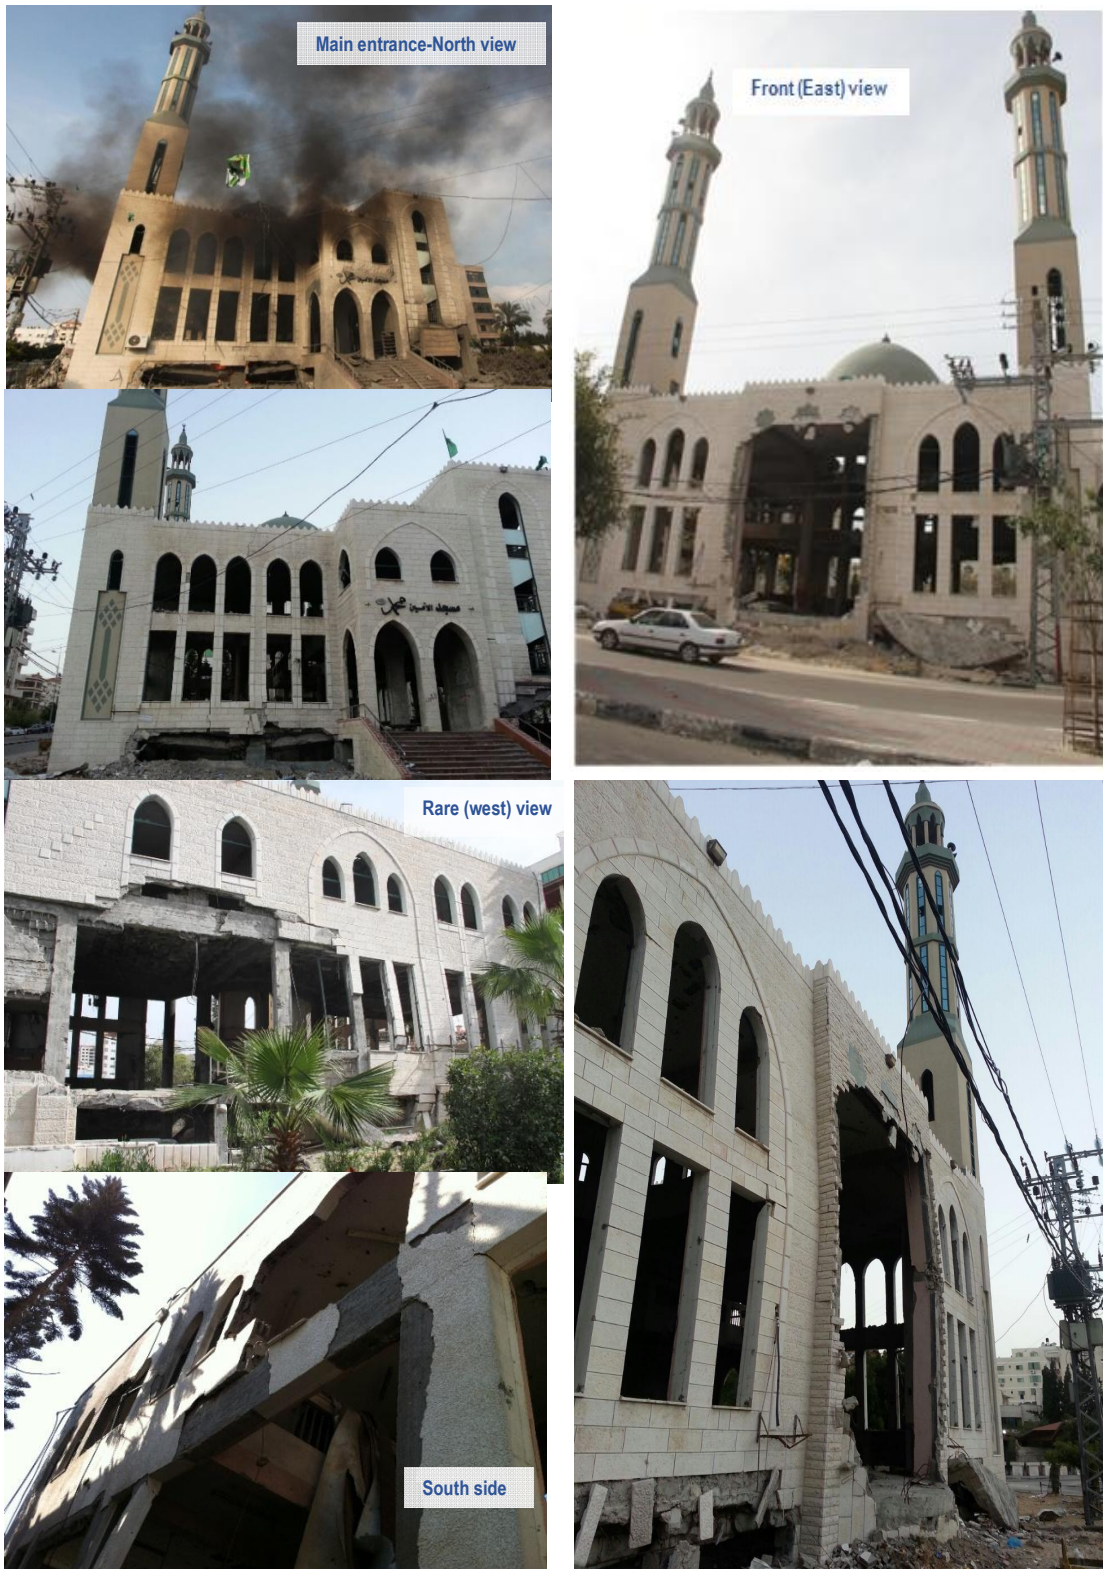
Fig. 2. Damage to Al-Amin Mosque- outside photos

other missile(s) exploded and caused severe damage to the building. As can be seen in Figs. 1, 2 & 3 the explosions occurred in the basement levels. Due to the explosion pressure, the main floor slab was lifted and bent upward causing tension cracks in the middle columns. Most exterior columns, except corners, were damaged and bent outward.

Based on visual inspections, the main floor slab was totally damaged, the mezzanine slab was severely damaged, and almost all columns were partially or totally damaged. However, the main roof slab appears to be in good condition except for two small holes (the missiles' entry holes). The two minarets and the dome are intact. In the basement level, the external earth retaining walls are generally in good shape with minor cracks at different locations. The foundations seem to be intact. The overall skeleton of the building appears to be integrated in spite of the severe damage to the main supporting columns.
